The PSA DISS Test Facility

The DISS Project: experimental results

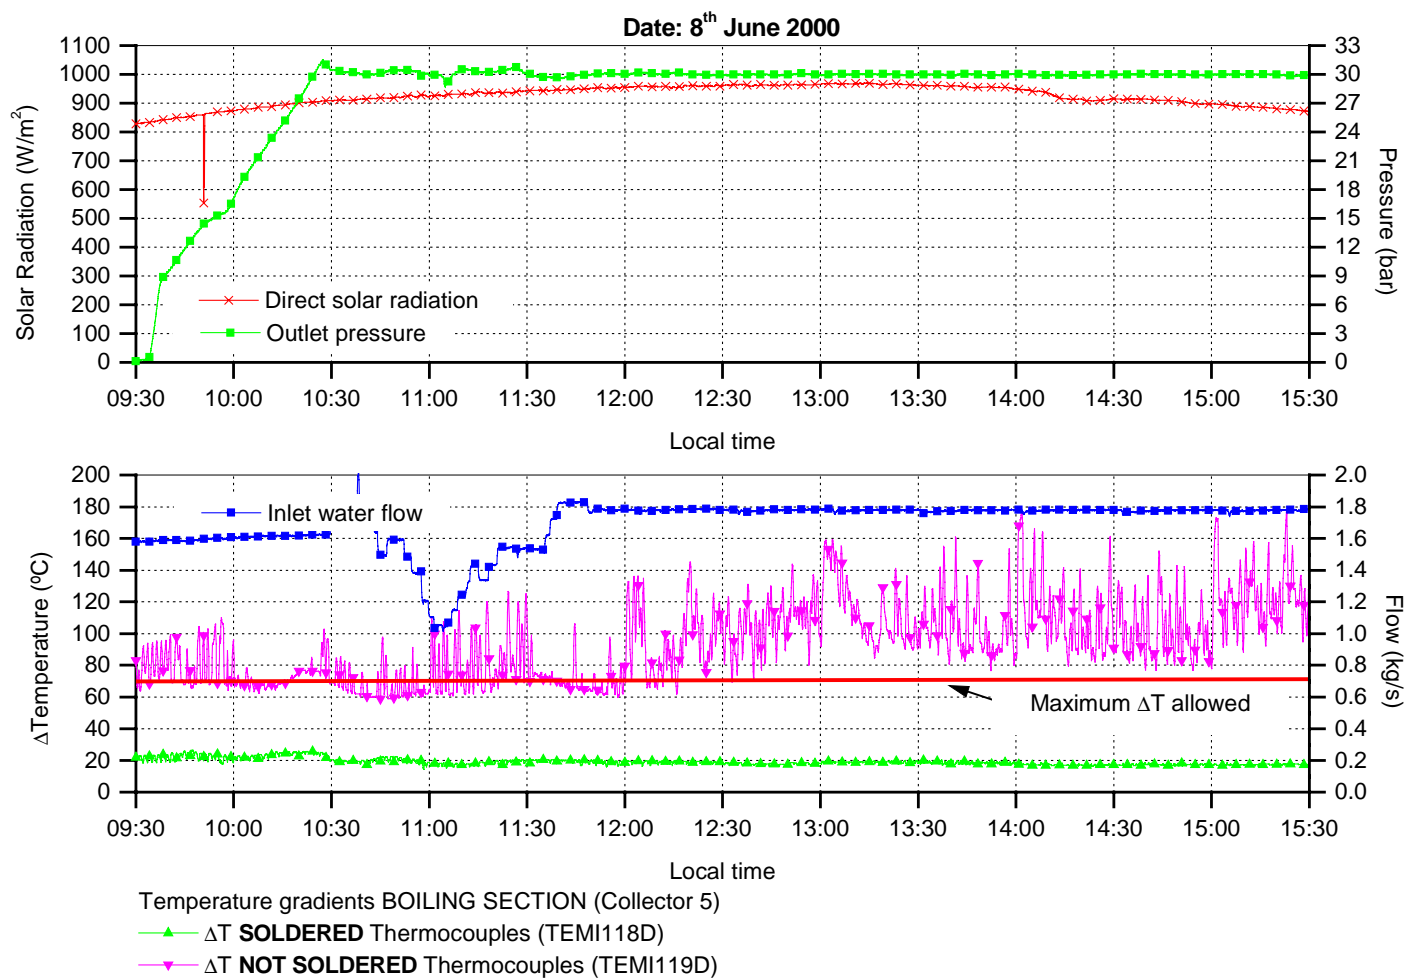
The DISS Project: experimental results (I)

- The high pressure/temperature ball joints are performing very well. No problem has been found so far.
- The circumferential temperature gradient at the absorber pipes of the boiling section is less than 20°C for $I = 950 \text{ W/m}^2$ and a flow of 0,8 kg/s, while the temperature gradient at the steam superheated section is of about 40°C for a steam flow of 0,5 kg/s (see Results I and II)

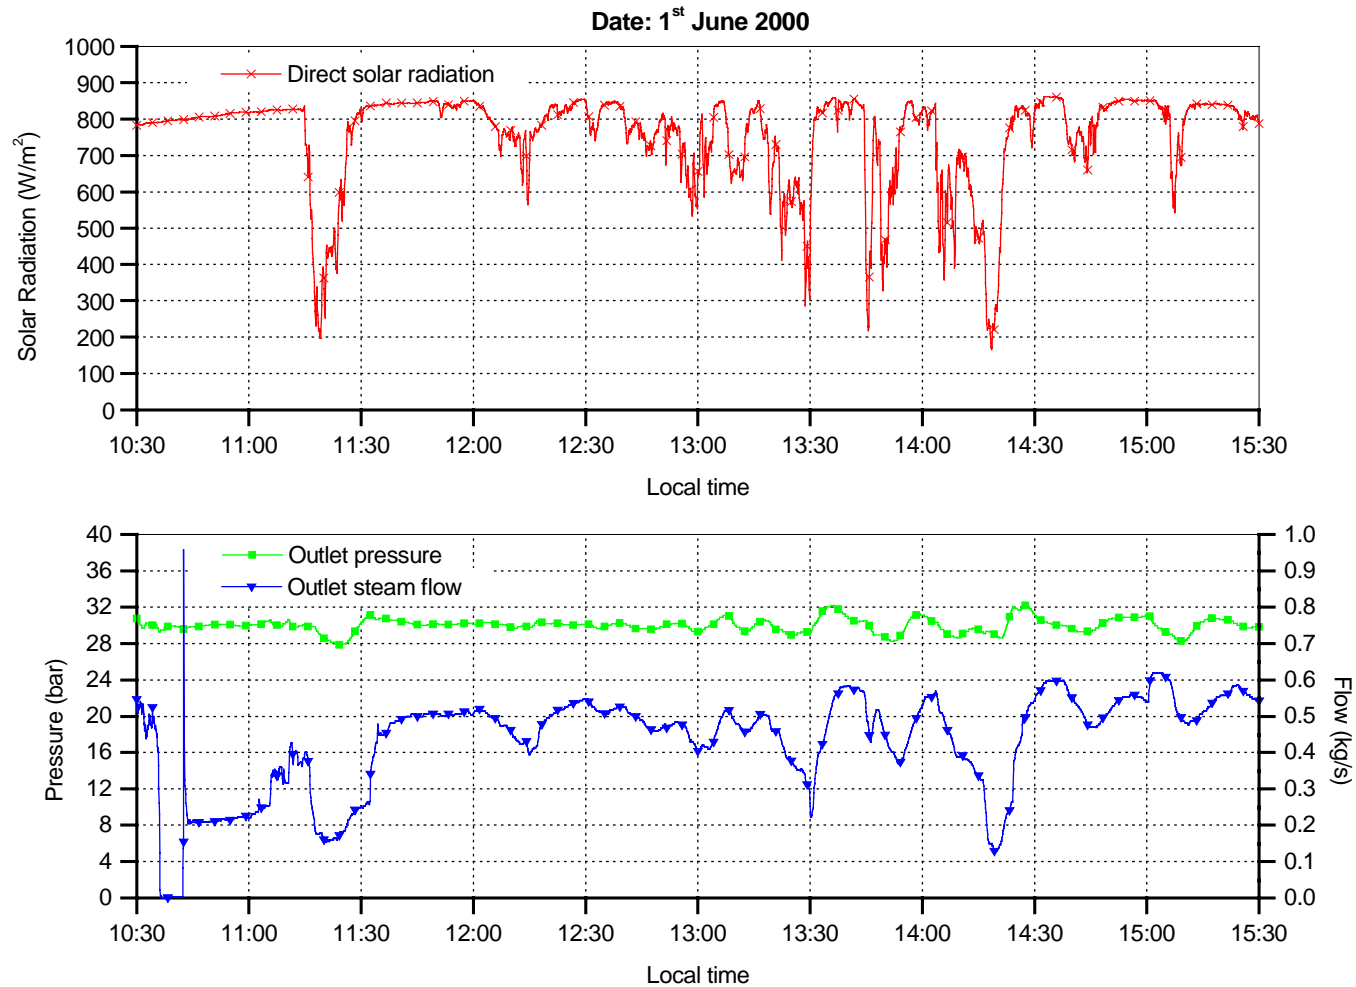
The DISS Project: experimental results (III)

- The steam pressure at the solar field outlet is rather stable, even with great solar radiation transients (see Results III and IV for 30 and 60 bar)
- The new local control unit developed by CIEMAT for sun tracking is performing very well

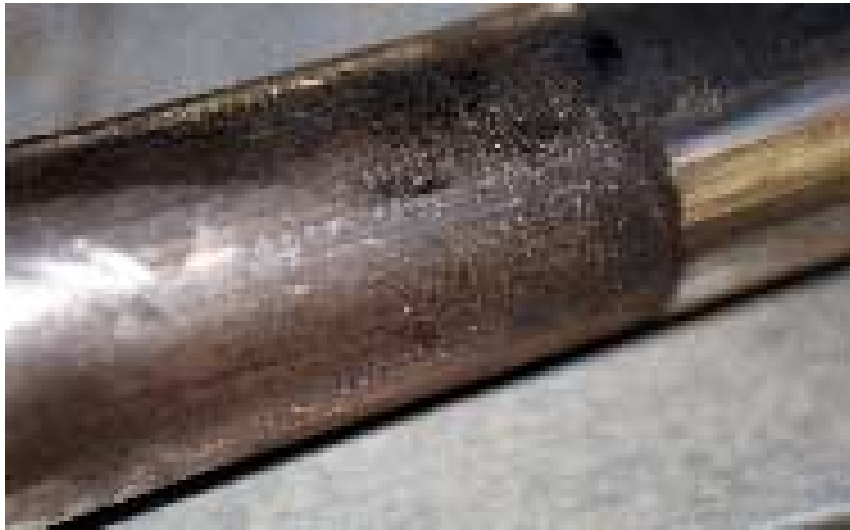
- The water recirculation pump has repeatedly failed at high pressures (>60 bar). After one year, the pump manufacturer (National Oil Well) is still trying to solve the problem.

detail of a damaged plunger

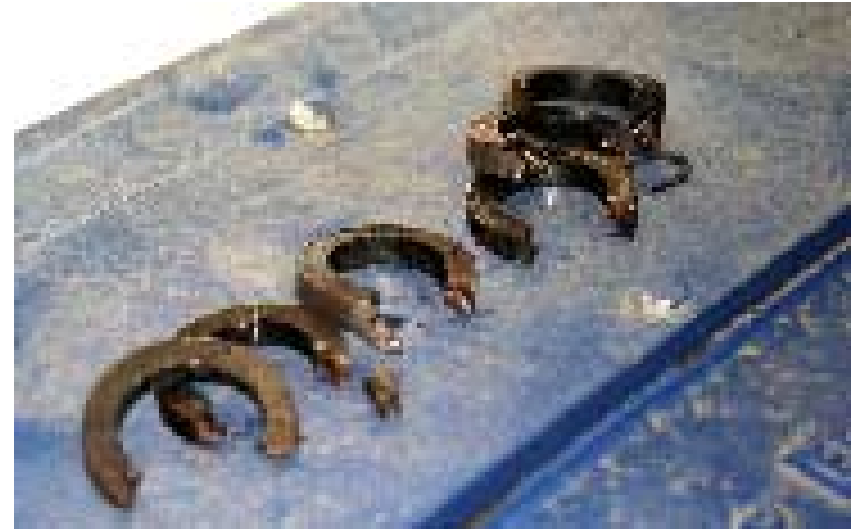
damaged graphite sealings
